Article

The Recent Discovery, Research, and Restoration of Medieval and Renaissance Frescoes in Riga Castle—A Treasure to the Baltic Region

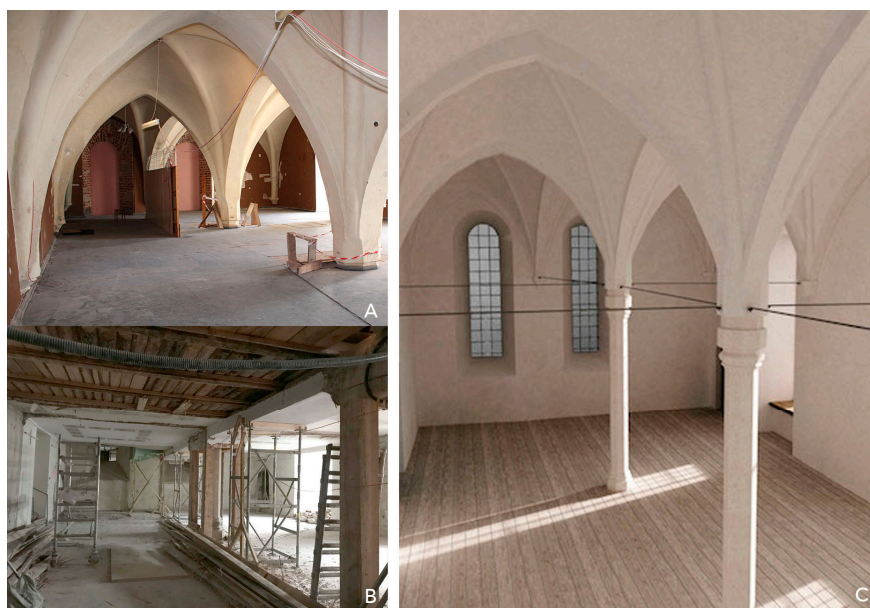
Figure 3. Chapel in Riga Castle. (A) Chapel, upper floor level, before restoration (photo: M. Rasiņa, 2018); (B) chapel, ground floor level, before restoration (photo: M. Rasiņa, 2020); (C) 3D visualization (by architect Reinis Liepiņš, 2015 [1]) of how the chapel will likely look after restoration.

The chapel (Figure 3) was a religious venue until the 19th century CE. After the Catholic period (13th–16th century CE), the chapel was used for Protestant services, and all the paintings found there were whitewashed. Then, under the reign of the Polish–Lithuanian Commonwealth (from 1582 to 1621), a policy of re-Catholicization appeared. After 1710, the castle was used as the Governor General's residence, and it was adapted for Orthodox ceremonies. In 1714, the chapel received a new altar [3]. A new iconostasis was installed in 1757 next to the first St. Mary's altar table. In 1747, the chapel received another entrance directly from the street by reconstructing one of the windows on the southern wall, which was redone in 1771 [6]. Until the mid-19th century CE, the place was renovated several times, with changes to the interior, windows, and entrances; however, in 1870, the Governor General of Russia (knaz Piotr Baration) decided that these premises were no longer suitable for their religious purposes. The room was divided into two floors in two years, just like the refectory next to it. The new rooms served the Governor General's purposes as archives.

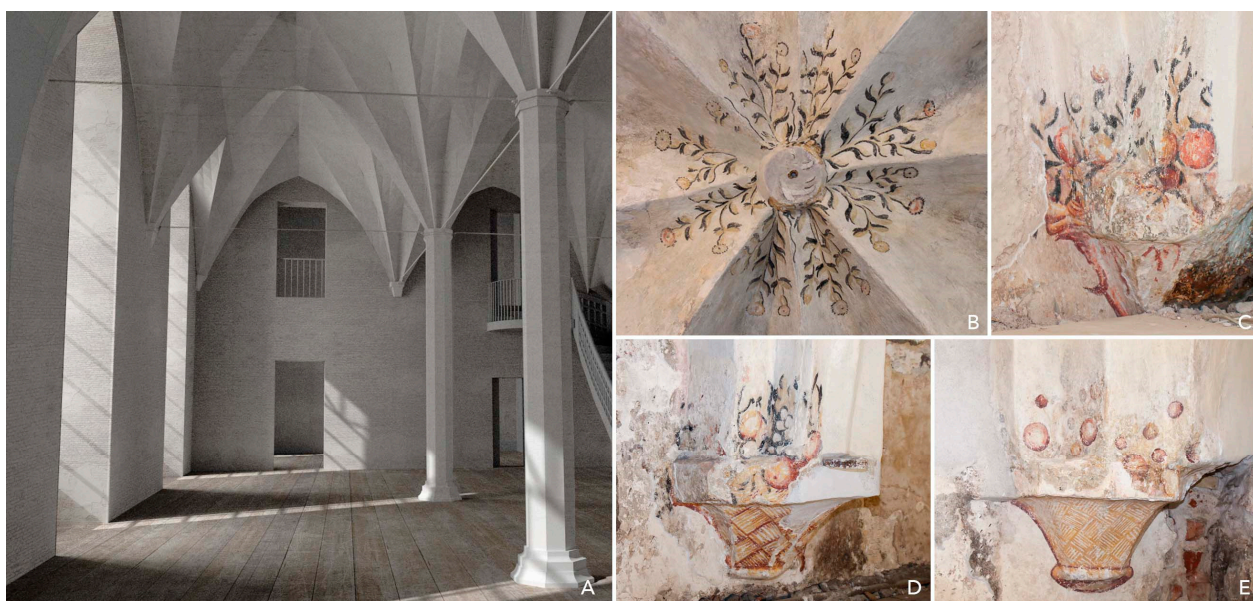
Figure 4. Refectory of the Riga Castle. (A) 3D visualisation of the possible look of the premise after restoration by architect Reinis Liepiņš, 2015 [1]; (B) vaulting's central painting after opening and restoration (photo: M. Rasiņa, 2020); (C–E) consoles after restoration (photo: M. Rasiņa, 2020).

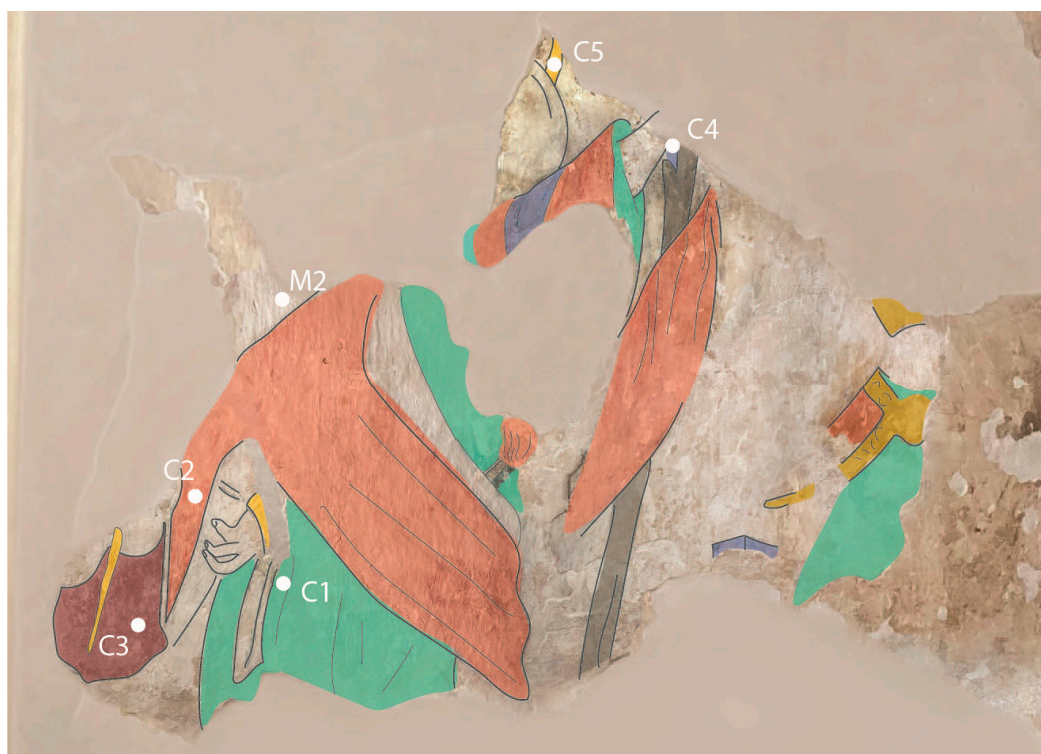
Figure 5. Sampling places for colouring and plaster mortar. Here, M2—plaster mortar, C1—green colour, C2—light red, C3—dark red, C4—blue, and C5—yellow. Part of medieval fresco, a sketch, chapel, Riga Castle, (drawing—M. Rasiņa and I. Vanadžina, 2021).

After discovering the fresco fragments in 2017, samples representing the colours, plasters, and mortars were taken for further research. Concerning the medieval remains, the painting in the chapel is the only remaining and vivid evidence of colouring so far. The following samples represent the plaster (M2) and the principal colours in the studied fresco, namely light green (C-1), bright red (C-2), dark red (C-3), blue (C-4), and yellow (C-5) (Figure 5 and Table 1).

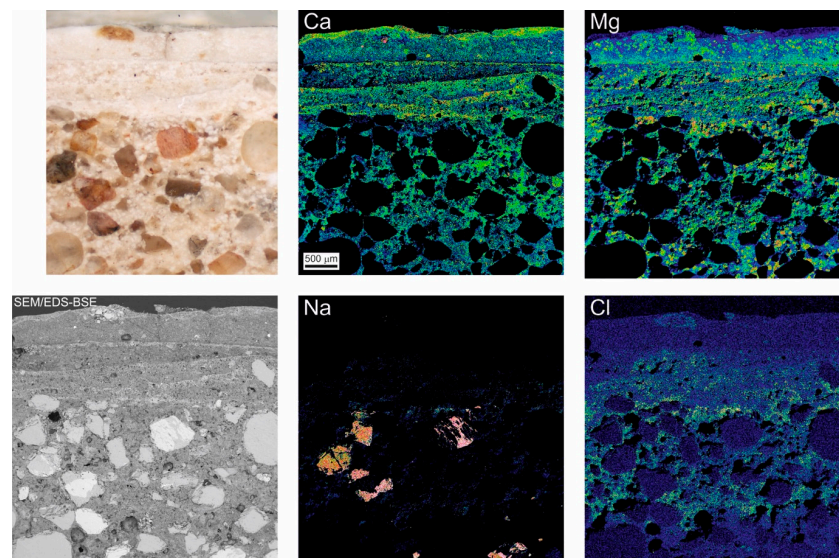
Figure 6. Sample M2 in optical microscope analysis and SEM/EDS microscopy by BSE imaging and elemental mapping (increased relative content is shown in a warmer colour for Ca = calcium (roughly corresponds to calcite or dolomite), Mg = magnesium (corresponds to Mg- and Ca-rich huntite-like phases and/or hydromagnesite), Na (larger grains in the mortar with high Na = sodium correspond to albite, increased content in mortar and polychromy layers can be connected to the increased content of Cl = chlorine, thus, reflecting the presence of water-soluble halite = NaCl).

The SEM/EDS elemental mapping also revealed the presence of water-soluble salts (sodium chloride and potassium chloride) in the mortar and some stucco layers (Figures 6 and 7).

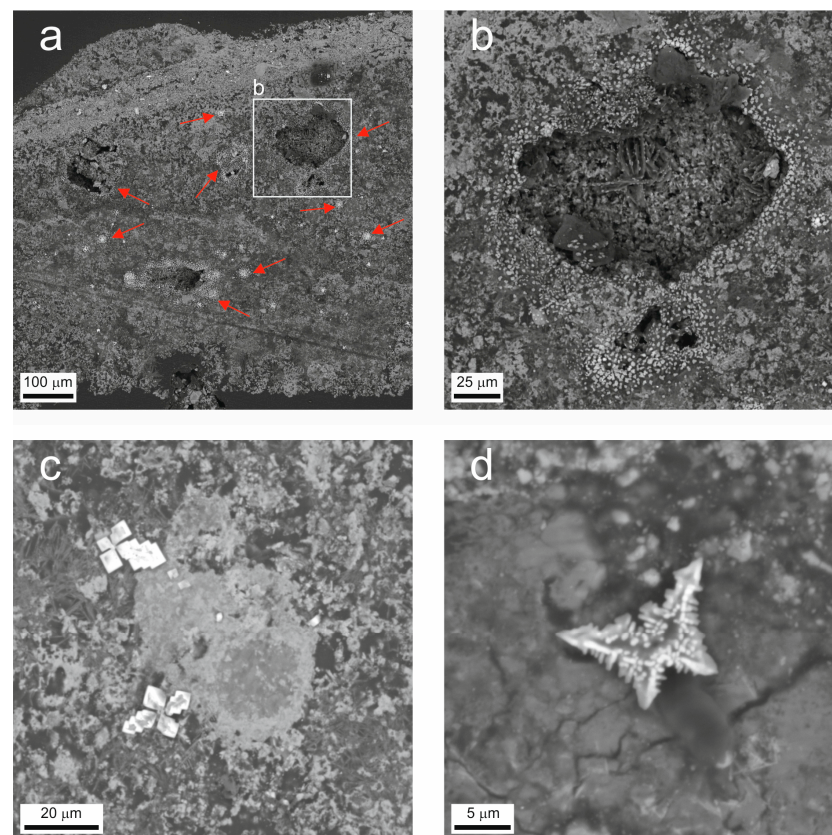
Figure 7. High salt content (dominated by KCl—sylvite, and subordinate NaCl—halite, indicated by red arrows on (a)) in studied fresco samples was confirmed by SEM/EDS microscopy; (b–d) different salt crystals in close-up in the same sample.

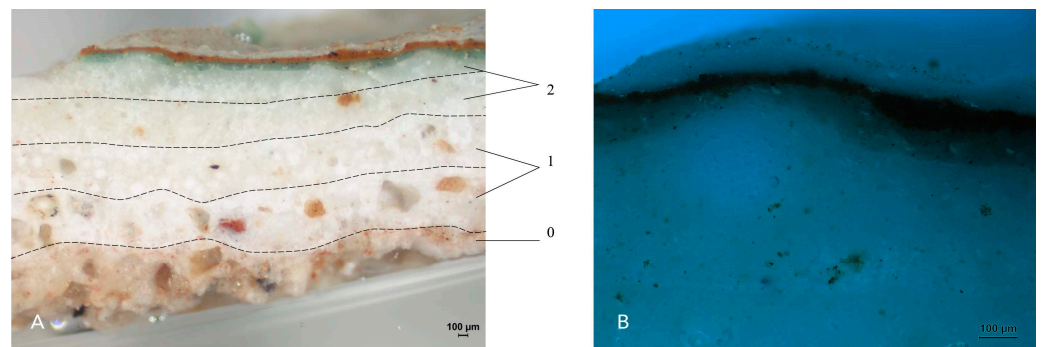
Figure 8. (A) Microscopic evidence of the combined fresco technique used for the medieval wall painting on the eastern wall of the chapel (Riga Castle), colour sample C1. Layer 0 represents the dolomitic lime plaster, layer 1 is comprised of two successive coatings of dolomitic stucco, layer 2 has two coats of dolomitic lime, and then the pigment layer was soaked into the final and top lime layer; (B) an optical microscope image showing the same area under UV light.

The above-mentioned analytical protocol also allowed for detailed determinations of the compositions of the colour layers studied and the stratigraphy of the wall painting. It consists of a core dolomitic plaster, two layers of dolomitic stucco, and two coats of dolomitic lime paint. In the last layer, traces of a drawing underneath with charcoal were discerned (Figure 8).

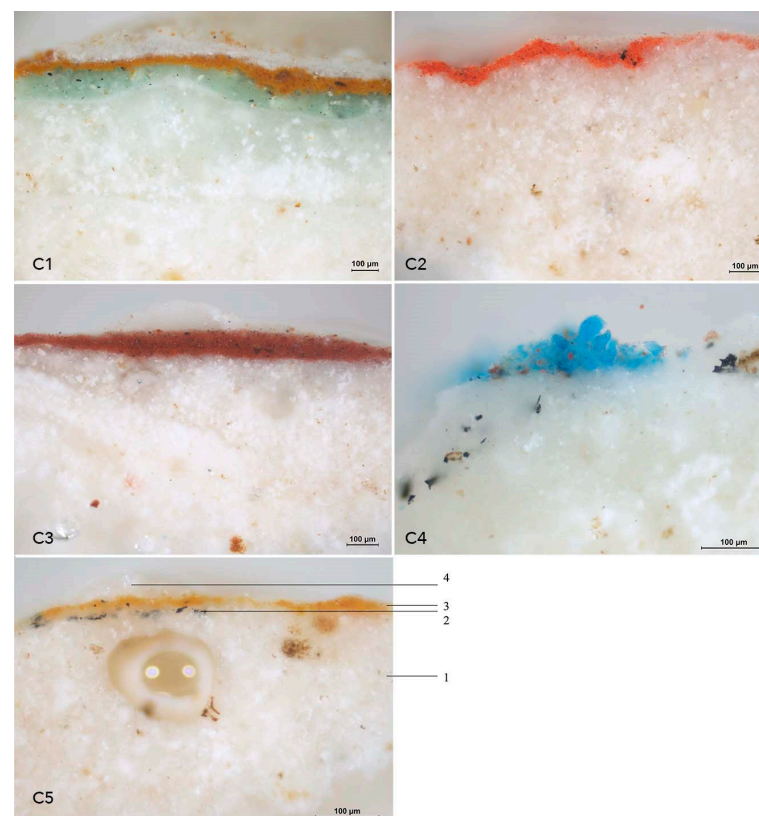
Figure 9. Microscopic evidence for the principal colours used in the medieval wall painting on the eastern wall of the chapel (Riga Castle). Iron oxide/hydroxide pigments were detected in samples C-5 and C-3, cinnabar in sample C-2, azurite pigment in sample C-4, and malachite pigment in sample C-1. Sample C-5 shows the colouring layers seen under the microscope: 1 = dolomitic lime, 2 = underdrawing with charcoal, 3 = pigment layer, 4 = lime crust on the surface (a later after-treatment).

The medieval chapel's painting had five colours—green, red, dark red, blue, and yellow. Dark red and yellow were detected as iron oxide pigments. Blue was an azurite pigment. Red was detected as cinnabar, and green as malachite (Figures 9 and 10).

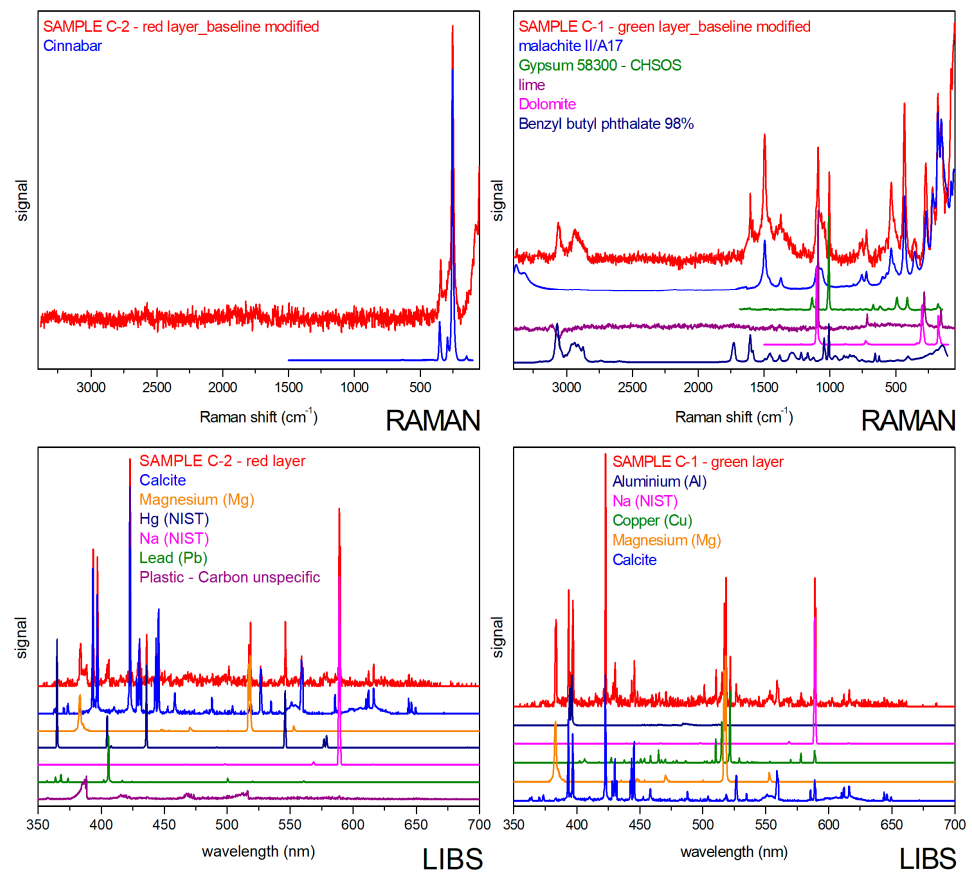
Figure 10. Raman and LIBS spectra allow for the recognition of cinnabar in the bright red coloured layer (sample C-2), and for malachite in the green coloured layer (sample C-1).

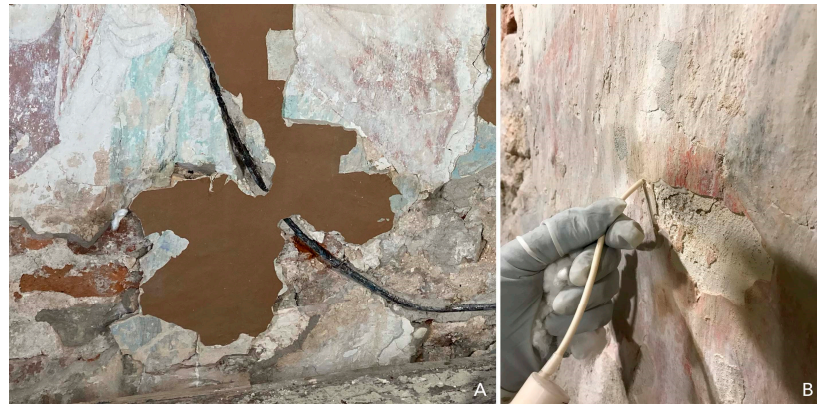
Figure 11. Chapel's fresco during the restoration works. (A) Restoration process in the opening up of the fresco (photo: M. Rasiņa, 2020); (B) conservation process by the introduction of lime-based injections (photo: M. Rasiņa, 2021).

After investigating the wall openings made in 2018, the interior appeared promising for the medieval painting to remain over a more extensive area than could be seen prior to the excavation. However, after the opening-up of the plaster, it revealed that only a few fragments of the essential parts of the original painting remained: the heads, shoulders, and the areas above the figures were missing, and mostly showing the much denser 19th century CE mortars. The original fresco was left so fragmented that even those pieces remaining were significantly damaged. One of the causes of destruction were electrical wires that were installed in the 1960s, which removed large areas of the remaining fresco (Figure 11).

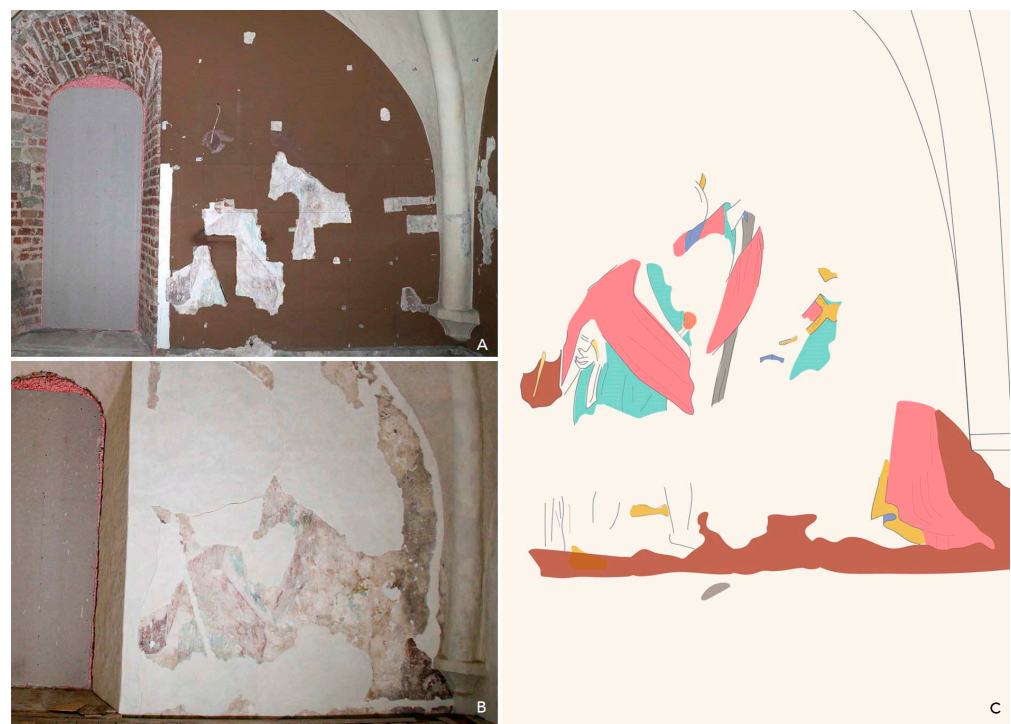
Figure 14. Chapel's fresco on the upper part of the wall. (A) Before restoration (photo: L. Irbeniece, 2020); (B) after conservation. Damaged plaster is conserved and fixed, and the lost areas are filled with lime plaster. On the fresco's surface, there is a historic white haze, still hiding the true colours of the painting (photo: M. Rasiņa, 2021); (C) A sketch of the chapel's fresco showing fragments of the medieval figurative painting (drawing: M. Rasiņa, I. Vanadzīņa, 2021).

After conservation, all of the 18th–20th century CE plasters were replaced by lime plaster and painted a neutral lime colour (Figures 12–14). The restoration works are still in progress, and the mode of the fresco's presentation in the chapel is being discussed. There are trials for surface cleaning of the white lime haze being carried out, and the project work group is discussing possible solutions for a better exhibition of the remaining fresco fragments.

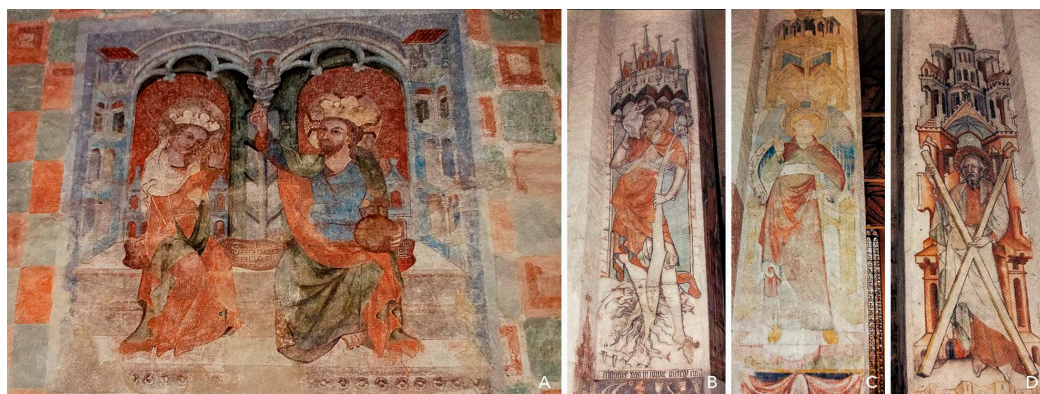
Figure 17. Figurative paintings in other Teutonic Order medieval castles or churches. (A) The Coronation of the Virgin Mary, Warmian Bishop Castle in Lidzbark Warmiński, Poland; (B–D) St. Christopher, Archangel, and St. Andrew figures in St. Mary’s Church in Torun, Poland [31].

The Hanse Union influenced the local adoration of saints important in other countries, such as St. John the Baptist, St. Peter, and St. John the Evangelist, or saints related to shipping and logistics, such as St. Jacobus, St. Nicolaus, St. Christopher, and St. Andrew. The iconography of these may be found in the names of churches and monasteries, altars, frescoes, and statues. There is a magnificent fresco of St. Christopher in the Church of St. Nicolaus in Wismar. It is a reminder that the church, built at the end of the 14th and 15th centuries CE, served sailors and fishermen. Another example is from the Hanseatic city of Thorn (today Torun in Poland), where there are frescoes of St. Christopher, St. Stephan, St. Andrew, St. John the Baptist, St. Lawrence, and the Archangel—the protector of pillars in the Church of St. Mary [31] (p. 111) (Figure 17B–D).

Because of the Teutonic Order's religious orientation based on a cult of the Virgin, we can assume that the chapel would have had frescoes of the Virgin and Christ. One of the remaining examples of the Order's depiction of this theme is the fresco with the Coronation of the Virgin Mary from the refectory in the Warmian Bishop Castle in Heilsberg (today Lidzbark Warminski in Poland) dated 1380 [31] (p. 37) (Figure 17A). The remnants of Riga Castle's frescoes only allow us to see the lower parts of the bodies, once painted with silhouettes of draperies and the presumed accessory details. However, if it was to depict St. Mary and Christ, it could be interpreted as Christ the Saviour, or Christ on one side, and the Virgin on the other. Dating of the Riga frescoes is unclear, as is much of the castle's history. Relating to recent studies, the eastern wall of the chapel is dated to the early 16th century CE, although from written artefacts, it is not clear how much of the old castle was integrated into the new one. The authors of this article consider that the dating could also be earlier. If so, the fresco could also date from the late 14th century CE or early 15th century CE, as in the mentioned related paintings in other Teutonic castles [31] or in the case of Riga Dome Cathedral [26].
